November 14, 2003

This letter is the eleventh Bi-Monthly Status Letter for Cooperative Agreement Number 1435-01-02-CA-85050, *Field Testing of a Physical/Biological Monitoring Methodology for Offshore Dredging and Mining Operations*.

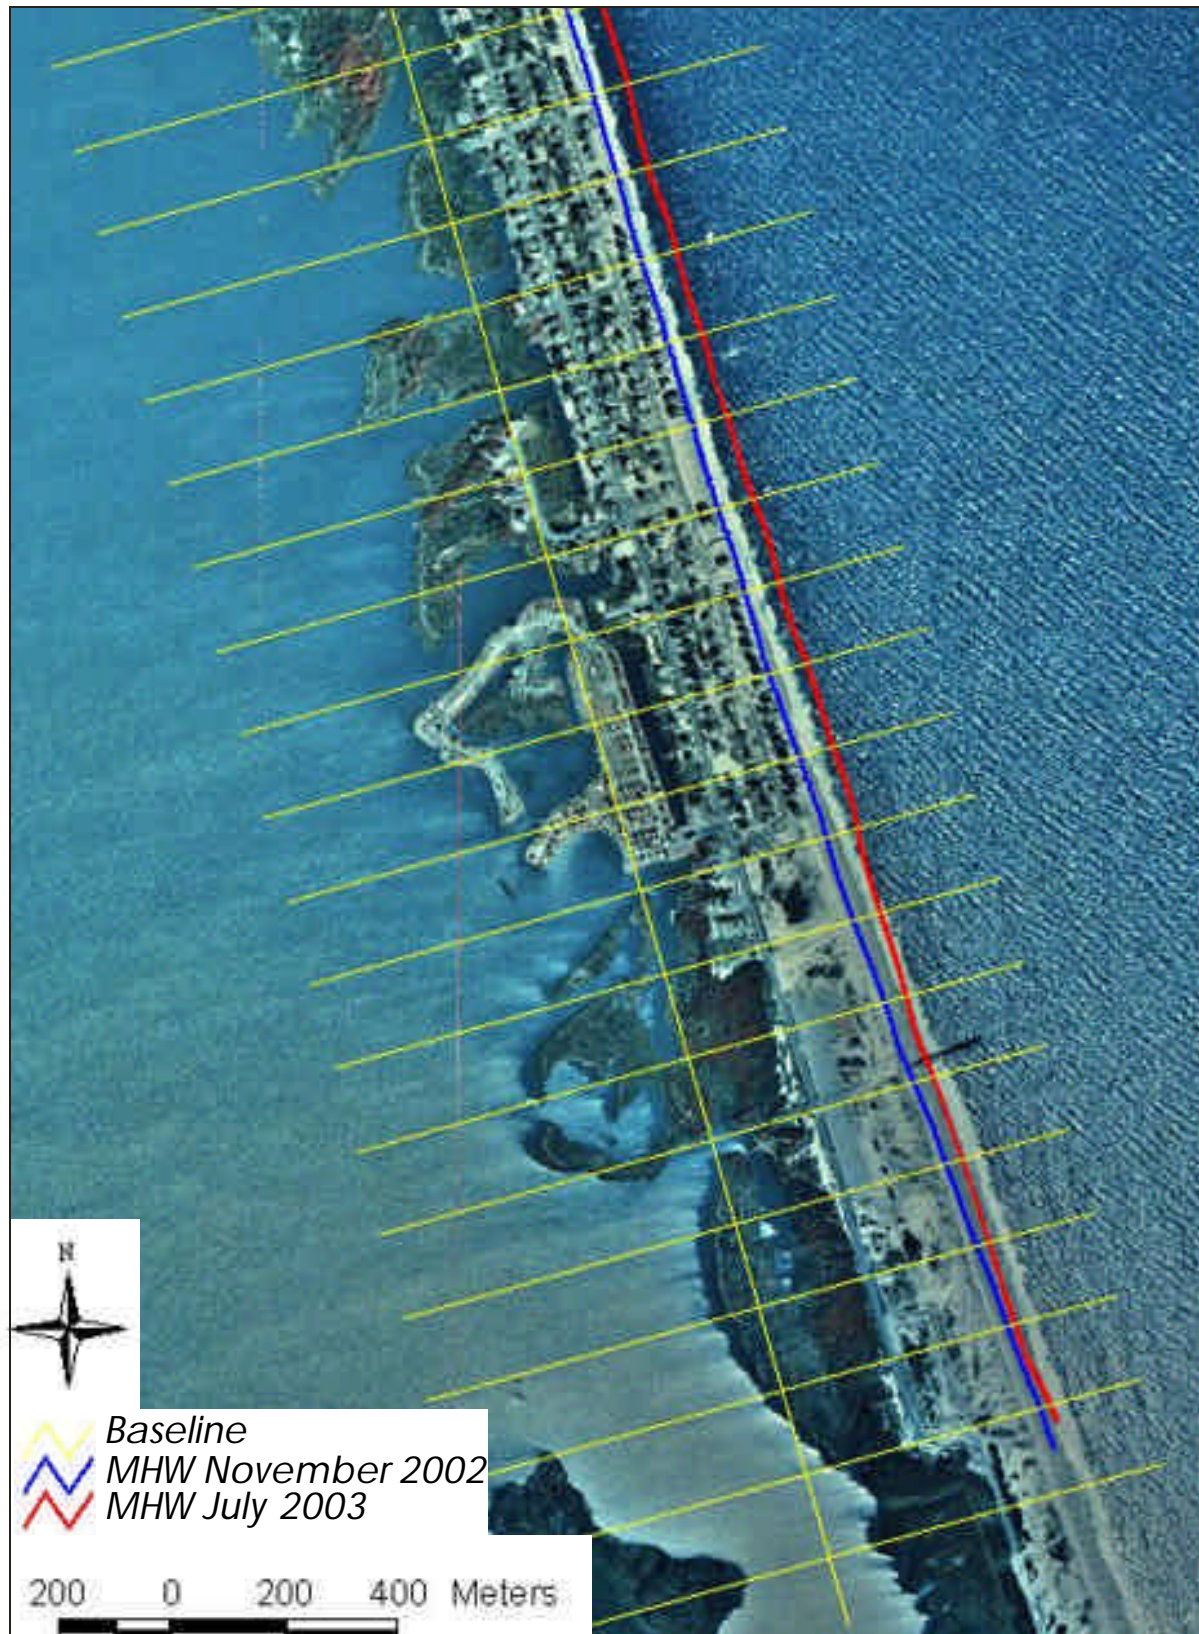
Figure 1: Aerial photograph of part of the Sandbridge study area with November 2002 and July 2003 mean-high-water shorelines superimposed along with a baseline and transects used for measurement of shoreline movement.

The ATV that we use for the alongshore beach surveying has been out of commission for several months as a result we have not been able to acquire a post-storm survey at Sandbridge. We do have access to cross-shore surveys taken by Waterway Surveying and Engineering every 500 feet at Sandbridge. We have finished processing the shorelines all of the raw profile data we have taken. We also have developed the methodology for analyzing those shorelines. The mean high water contour for each date is imported to ArcView. A baseline is drawn landward of the shorelines and an Avenue script developed for another project is utilized to determine the distance from the baseline to the shoreline along user-determined transects (Figure 1). These data are exported to an excel spreadsheet, and rates of change are determined.

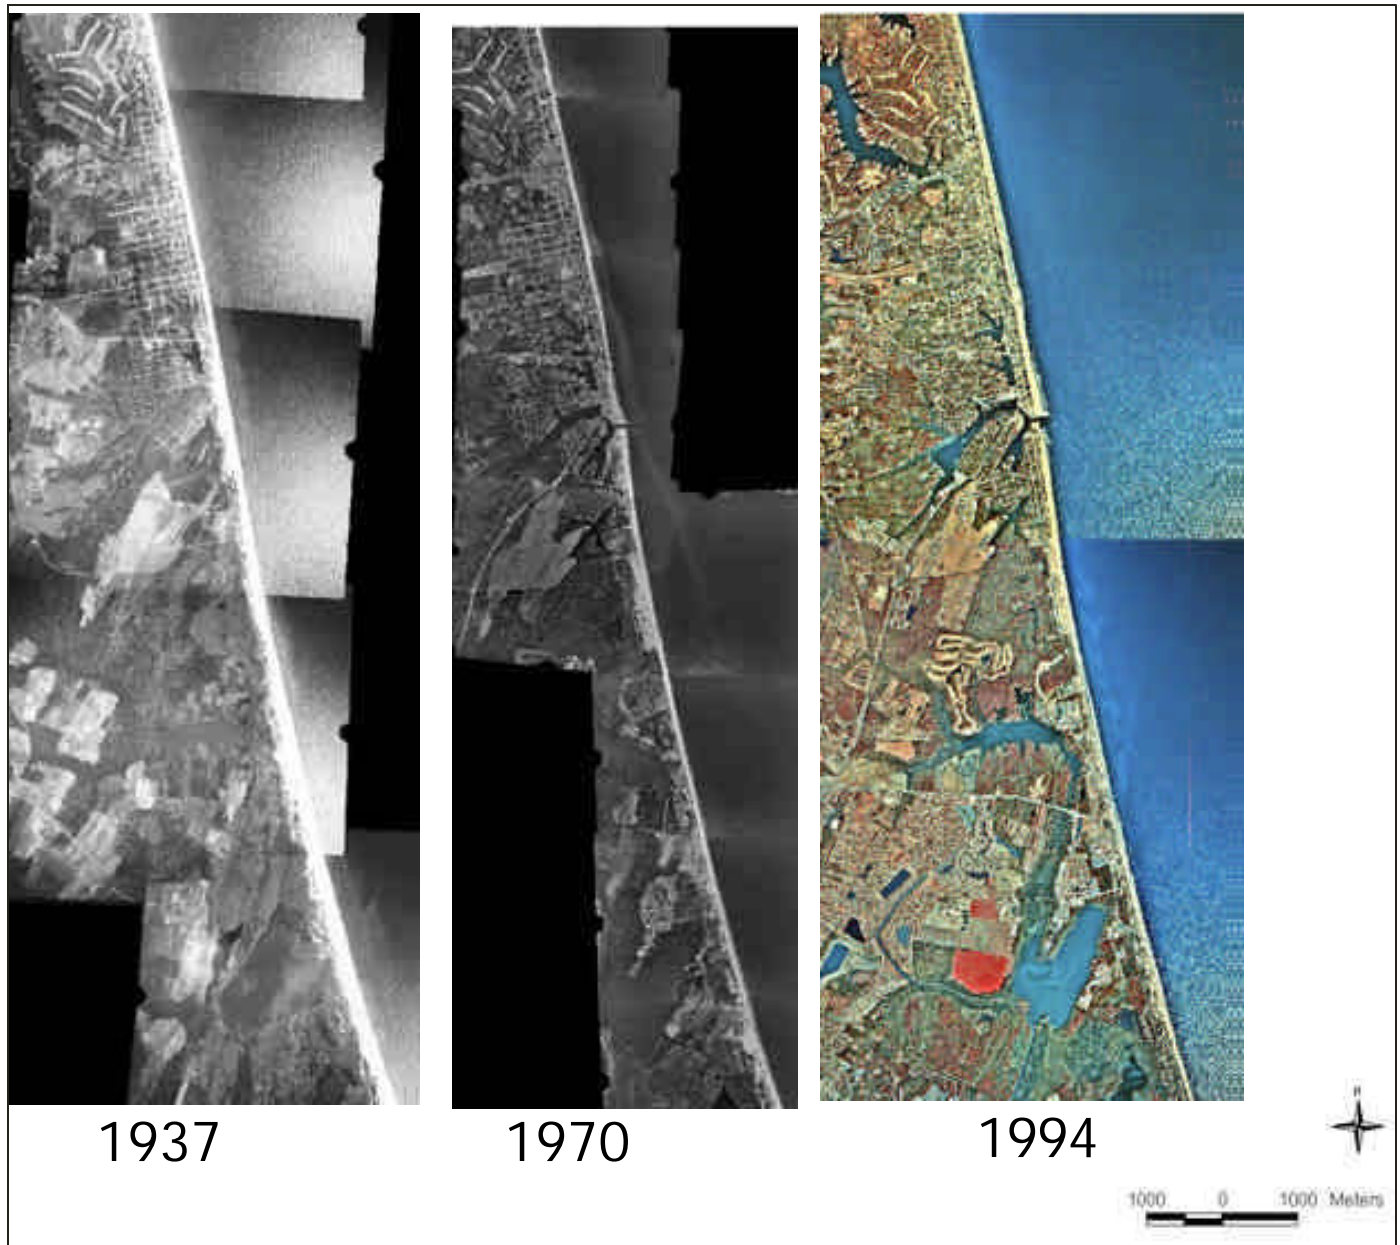
Figure 2: Ortho-rectified, photo mosaics from 1937, 1970, and 1994 for a portion of the Atlantic coast of southeastern Virginia. Rudee Inlet is clearly discernable about a third of the way down from the top in the 1970 and 1994 images.

We also have been looking at the long-term morphological evolution of the coast between Cape Henry and the North Carolina border. Figure 2 shows ortho-rectified historical photo mosaics for a section of the ocean coast in 1937, 1970, and 1994. Rudee Inlet is recognizable in the center of the later photos. The 2002 will also be added, the shorelines digitized, and rates of long-term change determined.

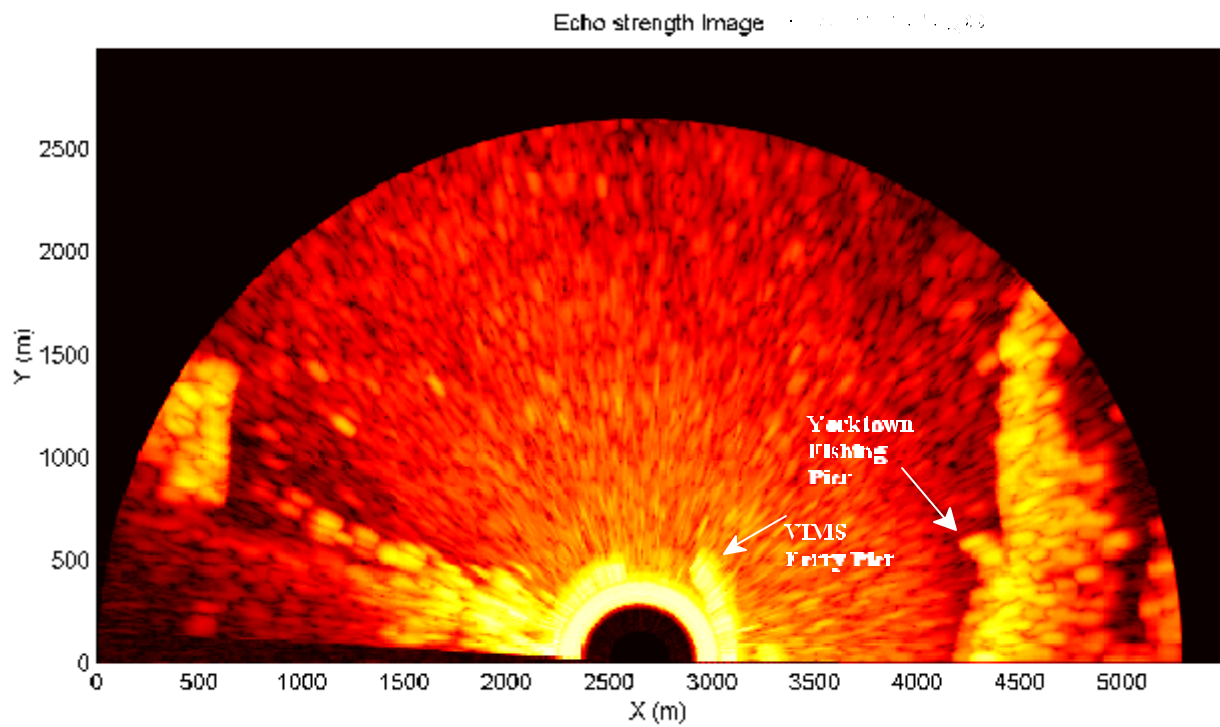
Figure 3: Radar image collected from the Furuno marine radar mounted atop Byrd Hall on the VIMS campus.

**Task 4:** Wave Studies: Jerome Maa reports that he has successfully collected radar images using the high speed A/D interface card purchased from Gage Applications. Figure 3 is a sample image. In this radar image, the VIMS pier and the fishing pier at Yorktown can be clearly seen. Currently, he is working to refine image collection. The Furuno 8251 marine radar sends out about 1750 burst lines within 0.8 seconds for a half circle radar image. This represents a size of 1 GB for one image. For our wave analysis purposes, this is more data than is needed, especially at the very early stage for one single wave height measurement. Therefore he is working to reduce the data-set size for a faster data processing. Dr. Maa expects this process can be done before the end of this year.

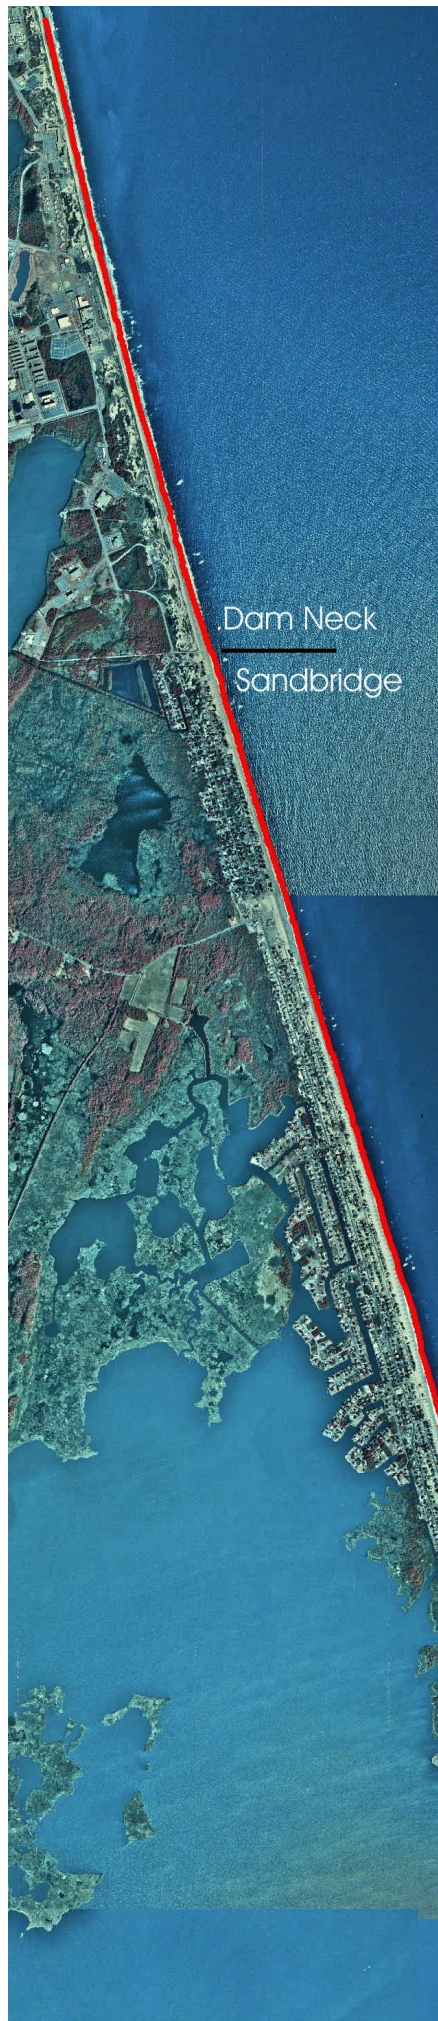
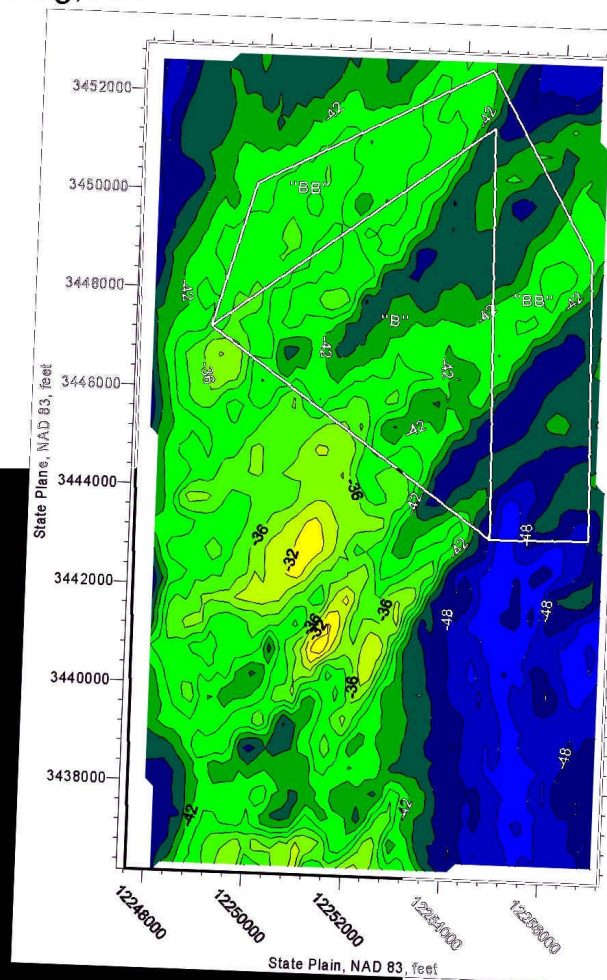
Photo Base 1994 DOQQ  
Red Shoreline, May 2003 by  
VIMS Shoreline Studies Program  
Offshore Dredging Data May 2003 by  
Waterway Surveys & Engineering, Ltd  
Weeks Marine

Finally, the last figure is the image that you requested earlier this fall depicting the Sandbridge Shoal dredge area within a photograph of the shoreline. Donna Milligan relates that the image was done in Arcview. The base photo is a 1994 digital orthorectified quarter quadrangle (DOQQ). The dredging map is proportionally correct and in the correct spot. The state plane coordinates (of the dredge area) had to be converted to UTM in order to overlay on the DOQQ. The May shoreline was surveyed with the pug. It is about mid-fill.
